USAAVSCOM TR-84-D-7

OIL DEBRIS DETECTION SYSTEM (ODDS)

Wayne A. Hudgins

Final Report

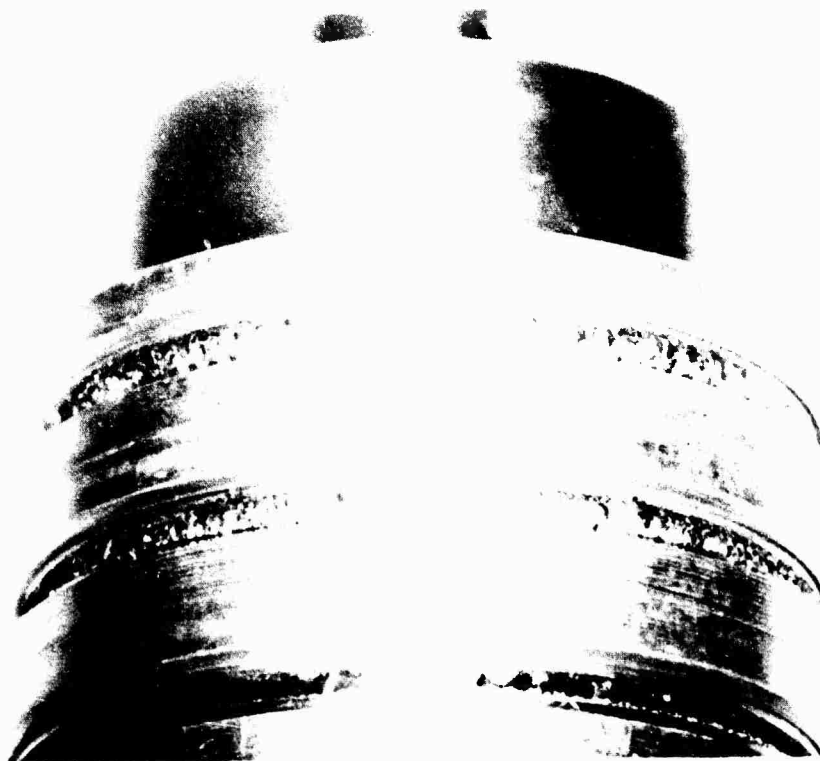
Figure A-6. Metal detected on mast bearing from DIR No. 13.
